The Open Dentistry Journal

RESEARCH ARTICLE

In Vitro Detection of Caries Around Amalgam Restorations Using Four Different Modalities

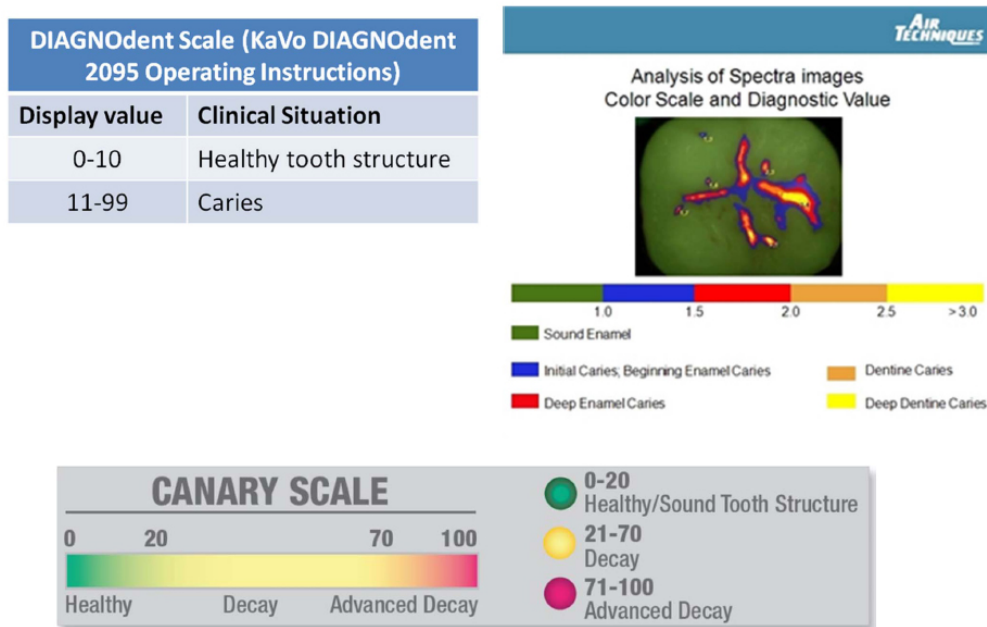
Figure 1 Caries Systems Detection Scales

Fig. (1). Scales for the caries detection devices employed in this study. A) The DIAGNODent Scale developed by Lussi et al. (2001) for detection of occlusal caries lesions. B) The Canary Scale. The Canary Scale is a relative scale of 0 - 100 that reflects the state of tooth mineralization and crystallization. This is a graduated scale where lower numbers indicate sound enamel and higher numbers indicate more advanced tooth decay. SPECTRA.

Another operator took DD and CS measurements at the centre of the amalgam, margin of the amalgam, 0.5 mm 1.5 mm and 2.0 mm away from the margin. Each measurement was done three times and all measurements were recorded. The means and standard deviation for each measurement were calculated. The measurement scales for the various systems are shown in Fig. (1).

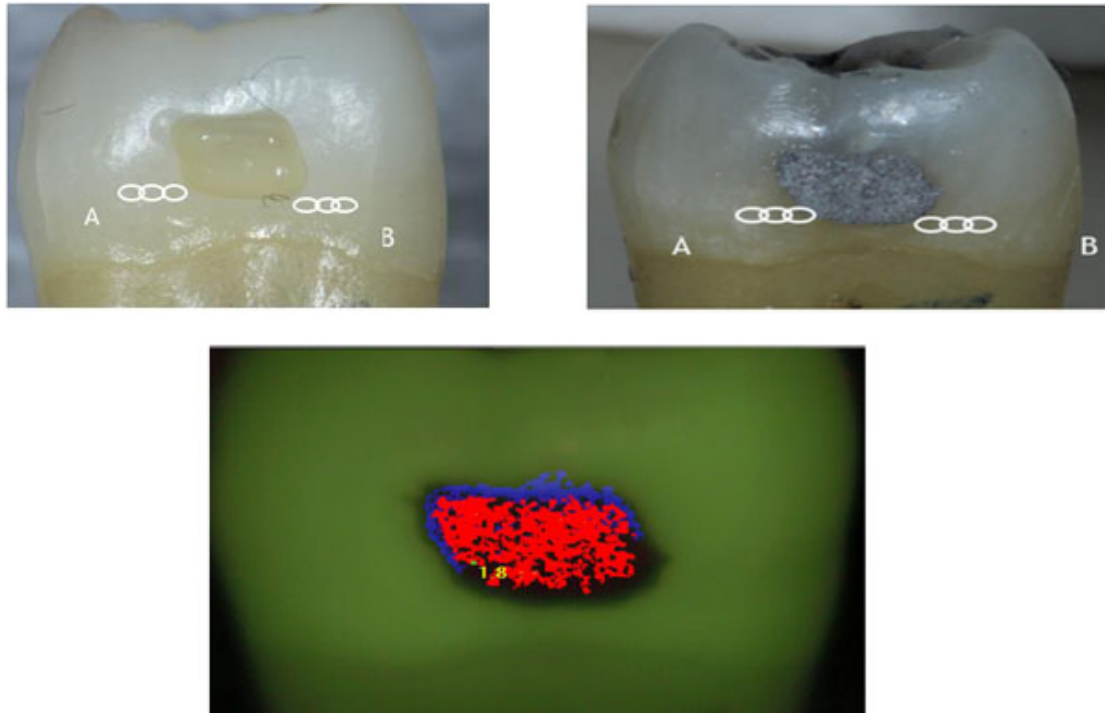
Fig. (2). Representative sound tooth before (A) and after (B) amalgam placement. The circles indicate triplicate measurements taken with SPECTRA at MOR, 0.5, 1.5 & 2.0 mm away from amalgam margin.

SPECTRA images of the amalgam restoration were all red indicating deep enamel caries. Along the margins of all the amalgam restorations, there were very thin blue or black lines (Figs. 2 and 3). The remaining tooth surface appeared green indicating sound enamel even if caries was present beneath the amalgam margin. SPECTRA measured surface

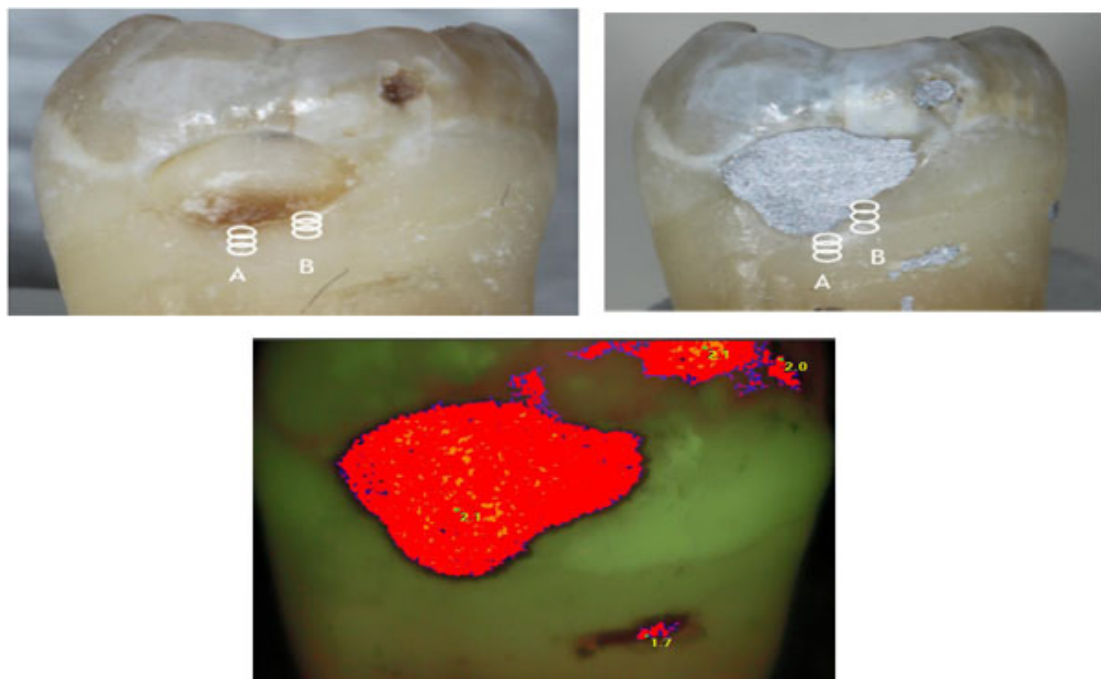
Fig. (3). Representative carious tooth before (A) and after (B) amalgam placement. The circles indicate triplicate measurements taken with SPECTRA at MOR, 0.5, 1.5 & 2.0 mm away from amalgam margin.

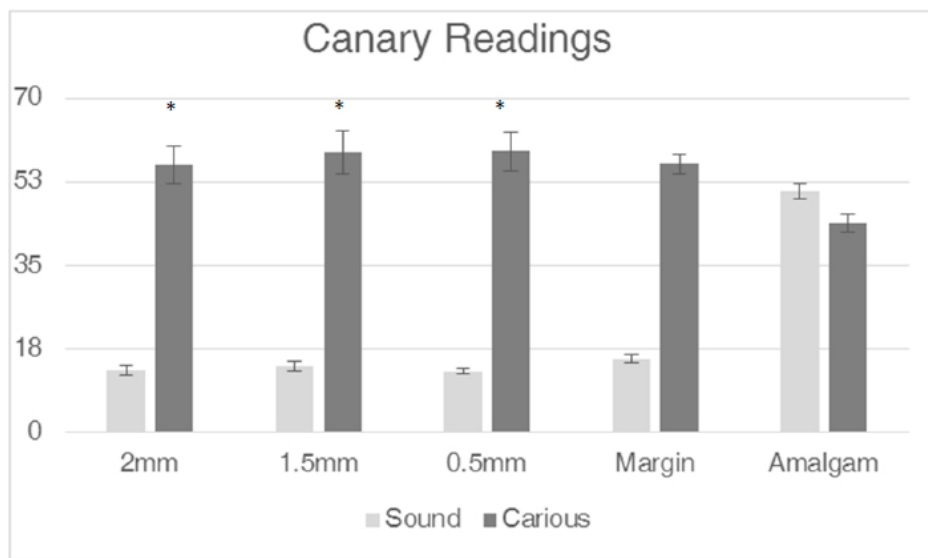
Fig. (4). Mean Canary Numbers at MOR, 0.5, 1.5 and 2 mm from the margin into tooth structure for sound teeth and carious teeth. Asterisks (*) indicate statistical significance at $P < 0.05$.

Figs. (4 and 5) show the mean Canary Number and DIAGNODent readings on the centre of the amalgam restoration and at various distances from the margins of the restoration. The Canary system gave readings of 46.2 ± 8.4 and when measuring on the centre of the amalgam restoration on the healthy and carious samples. At the margin of the restoration, the CN reading from carious samples were 56.3 ± 9.4 . On healthy samples at the margin of the restoration the CN dropped to 15.4 ± 3.1 . The measurements at 0.5, 1.5 and 2.0 mm away from the amalgam margin on healthy samples the CN remained below 20 indicating no caries present. However, on teeth with caries beneath the amalgam margins the Canary Number measurements at 0.5, 1.5 and 2.0 mm away from the amalgam margin gave mean ranged between 56.1 and 58.9 indicating that there was caries beneath the margin or near to the margin wall underneath the surface enamel. The Canary Number did not drop significantly at 2 mm away from the amalgam margin on carious samples. Table 1 indicated that The Canary system had very high sensitivity and specificity rankings. For Canary System, sensitivity/specificity for sites at 2.0, 1.5, 0.5, and on the amalgam margin ranged from 0.95-1.0 / 0.85-1.0, respectively (Table 1).

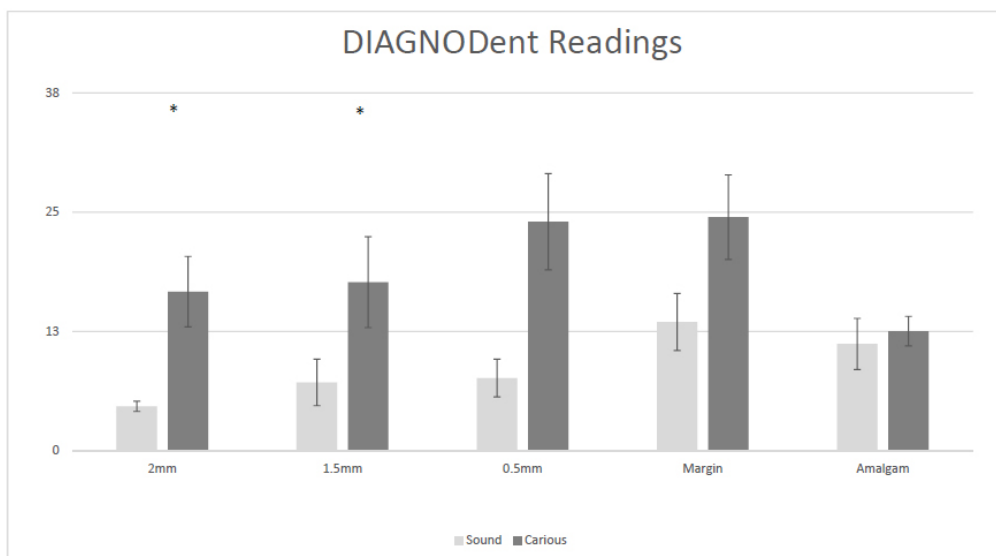
Fig. (5). Mean peak values for DIAGNODent at MOR, 0.5, 1.5 and 2 mm from the margin into tooth structure for sound teeth and carious teeth. The asterisks indicate statistical significance at $P < 0.05$.

DIAGNODent gave readings of 12.1 ± 7.8 when taking measurements on the middle of the amalgam restoration for both sound and carious samples. At the margin of amalgams placed in healthy teeth the DIAGNODent reading was 13.5 ± 10.4 and dropped to 4.7 ± 1.8 at 2 mm away from the amalgam margin. On teeth with caries beneath the amalgam margin DIAGNODent readings at the margin were 24.5 ± 20.8 and dropped to 16.7 ± 16.5 at 2mm away from the amalgam margin. For DIAGNODent, sensitivity/specificity for sites at 2.0, 1.5, 0.5, and on the amalgam margin ranged from 0.74-0.52 / 0.54-1.0 (Table 1).
