Efficacy of Light-Activated Sealant on Enamel Demineralization in Orthodontic Patients: An Atomic Force Microscope Evaluation

Abstract: *Objective:* The purpose of this study was to investigate the efficacy of (Pro Seal) sealant in preventing enamel decalcification *in-vivo* and compare its effect with fluoride varnish and unfilled sealant using atomic force microscopy.

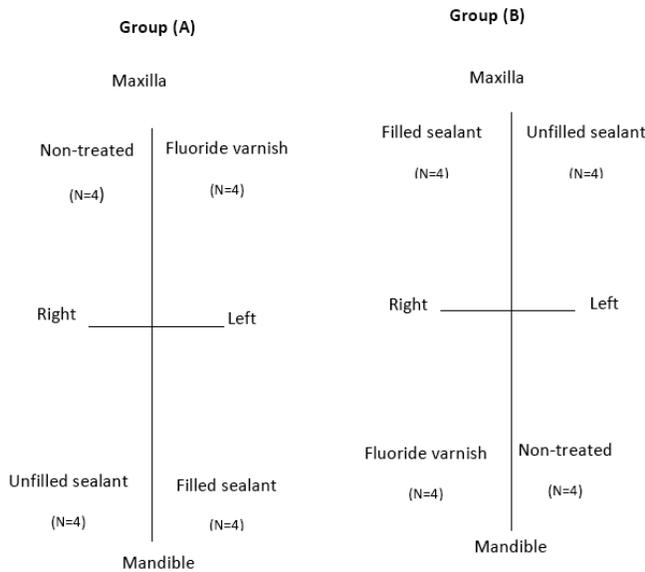
Fig. (1) Study design.

premolars (4 maxillary and 4 mandibular), study design illustrated in Fig. (1).

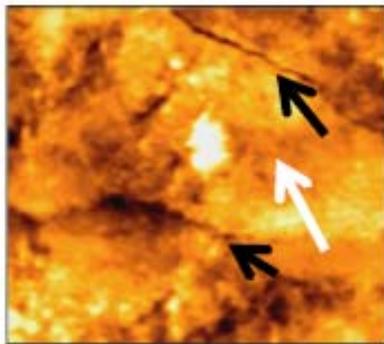
Fig. (2). Narrow grooves (black arrows) and flattened perikymata ridges (white arrows) with cracks and many destructed areas of non-treated enamel surface (50x50 μm).

AFM tapping mode images of 50x50 μm scanned area revealed that the enamel surface presented narrow grooves and flattened perikymata ridges with cracks and destructed areas in the surface (Fig. 2). The 3-D image showed high surface irregularity and focal deep areas corresponding to the cracks seen in the 2-D image (Fig. 3). The enamel surface presented an obvious defective crystal arrangement with wide inter-crystalline spaces (Fig. 4).

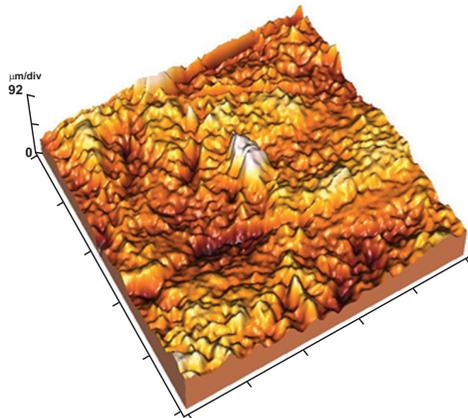
Fig. (3). 3-D image showing high surface irregularity with localized deep areas.

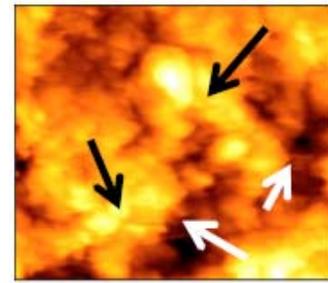
Fig. (4). Tightly packed crystals (black arrows) with focal destruction areas (white arrows) (10x10 μm).

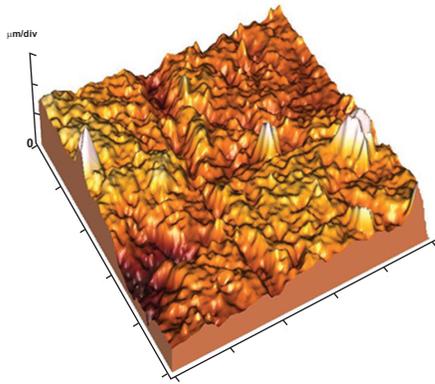
Fig. (6). 3-D image showing highly rough enamel surface with wide perikymata grooves.

enamel surface in the 3-D image (Fig. 6). The images of 10x10 μm scan area revealed tightly packed crystals with

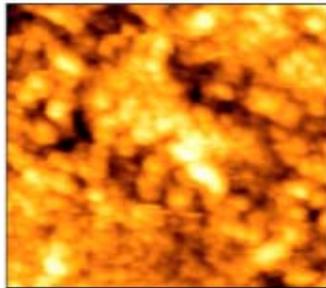
Fig. (7). Defective crystal arrangement of varnish treated enamel surface (10x10 μm).

focal destruction areas (Fig. 7).

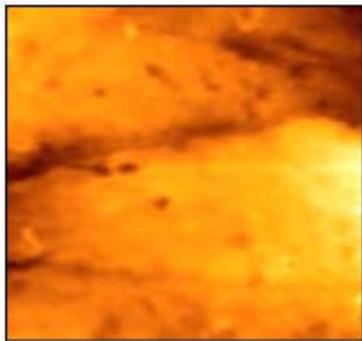
Fig. (8). AFM image of unfilled sealant group presented wide perikymata grooves and flattened perikymata ridges (50x50 μm).

The enamel surface showed moderately wide but shallow perikymata grooves and localized areas of destruction in the enamel surface (Fig. 8). The surface appeared with moderate roughness in the 3-D image (Fig. 9). Tightly packed enamel crystals with no evidence of focal holes was detected in 10x10 μm image (Fig. 10).

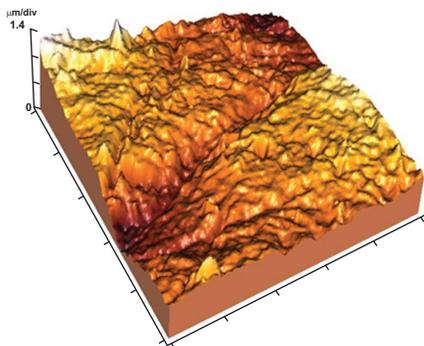
Fig. (9). 3-D image showing moderately rough enamel surface and wide perikymata groove.

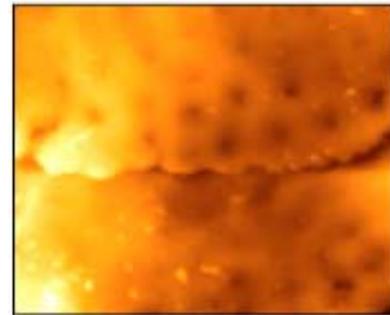
Fig. (11). AFM image of pro seal treated enamel showing perikymata ridge and groove with obvious focal holes (50x50 μm).

The enamel surface showed perikymata grooves as wave-like parallel rings and obvious perikymata ridges. The enamel surface exhibited localized depressions (focal holes) with no evidence of rod ends (Fig. 11). The 3-D image revealed relatively smooth enamel surface (Fig. 12). Images of

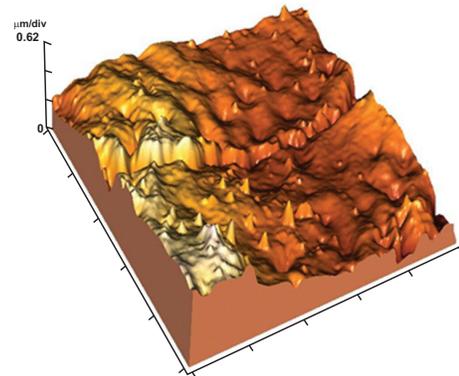
Fig. (12). 3-D image of (Fig. 2) showing relatively smooth enamel surface between the focal holes.

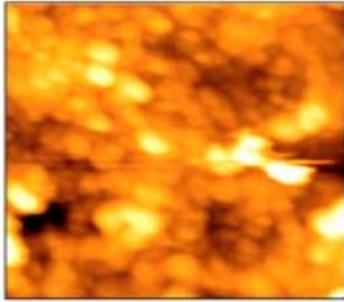
Fig. (13). AFM image showing tightly arranged crystals around conical depressions (10x10 μm).

10x10μm revealed the presence of conical depression (focal holes) surrounded by tightly arranged crystals (Fig. 13).

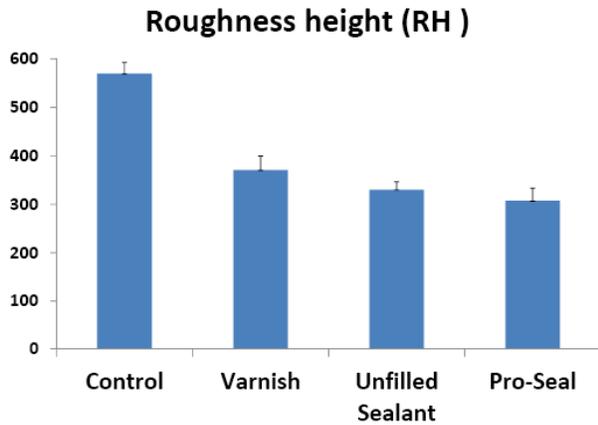
Fig. (14). Histogram showing the mean roughness height in the different groups.

The means and standard deviations of the roughness height (RH) and total surface area (SA) of the scanned areas were represented in Table 1 and Figs. (14, 15). One way ANOVA test revealed that RH and SA in the untreated group were significantly higher than other groups while the Pro Seal group showed the smallest values mean. There were significant differences (p<0.001) between three treatment groups and the untreated group concerning RH & SA (Tables 2-5).

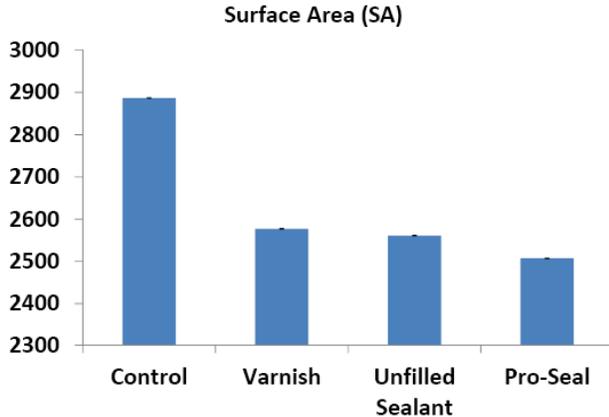
Fig. (15). Histogram showing the mean surface area in the different groups.
